## Autopsy of an old reverse osmosis membrane from Cap Djenet seawater desalination plant: case study of Algeria

S. Talantikite<sup>1</sup>, K. Benrachedi<sup>1</sup>

The seawater desalination plant is located on the Boumerdes city in Northern east of Algeria to provide the drinking water for the inhabitants. This unit started to run in 2012 operating continuously with nominal capacity of 100.000m<sup>3</sup>/day, a conversion rate of 45% and a feed water salinity between 35 and 40 g/L. In our study, the membranes located in first position (DOW FILMTEC SW30 HRLE-400i, serial number F4810019) and was analyzed.

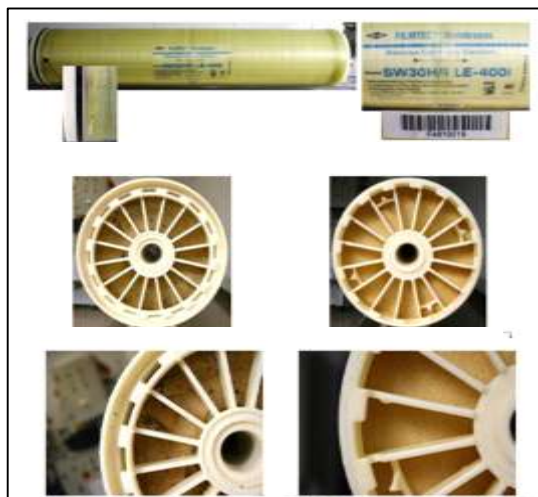
(a)

This visual external inspection of fouled membrane shows:

- some fissures were detected on external housing (feed end).
- presence of some particles which was observed on element feed end (photographs 3 and 5).
- no telescoping or significant spacer protrusion was detected.

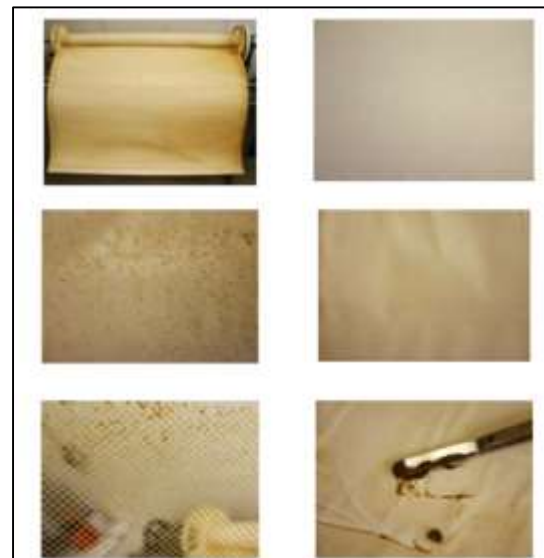
(b)

This visual internal inspection of fouled membrane shows:

- Presence of brown fouling was detected all over the surface. Same kind of fouling was observed on spacer material, mainly on feed side.
- Presence of a black mass that at first glance appeared like a bacterial colony. A similar results were observed by previous studies [12,13].Some studies suggest that this phenomenon was ascribed to the foulants which have been deposited on the membrane surface rather than formed by a precipitation mechanism [14].
- No additional details were observed on membrane surface. No significant failures were detected.

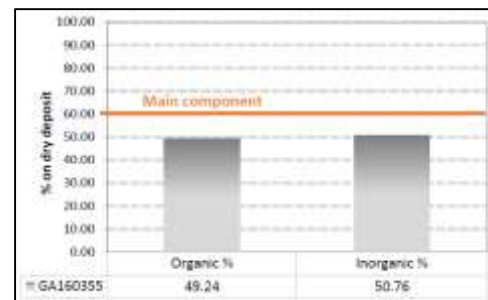
**Figure 3.**Loi results obtained from GA160355 membrane fouling

The Figure 3 describes LOI data obtained for GA160355 (1st position) fouling data. Considering these results, fouling from GA160355 membrane surface shows similar organic and inorganic content.

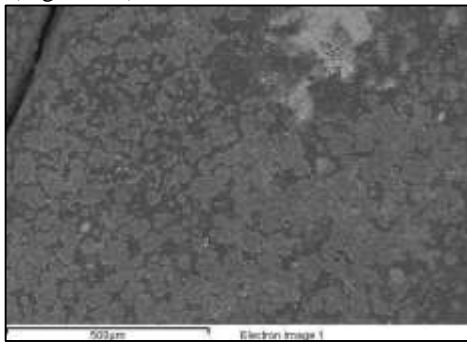
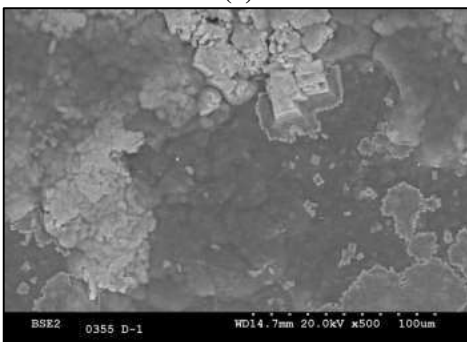
The SEM micrograph of fouling from membrane surface shows an organic fouling mixed with sodium chloride from sea water.

There is also presence of aluminosilicates and common elements on sea water membranes (Figure 4 (a) and (b)).

The SEM Microphotograph 2F of membrane fouling shows that fouling looks organic with presence of inorganic crystalline structures (Figure 4 (b)).

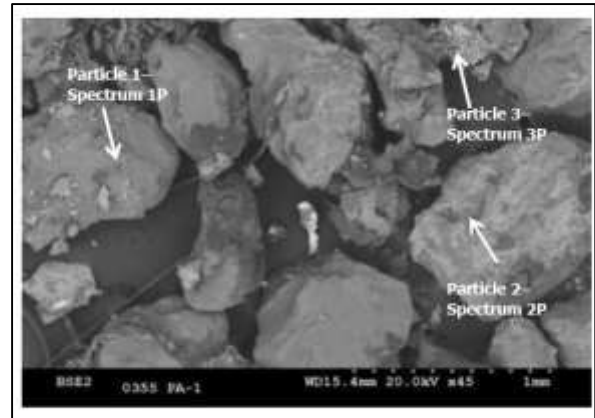
(c)

The SEM micrograph of particules from feed end showed grains with presence of organic matter, sodium chloride, silica and metallic components.

They are probably fouled silica grains (Figure 4 (c))

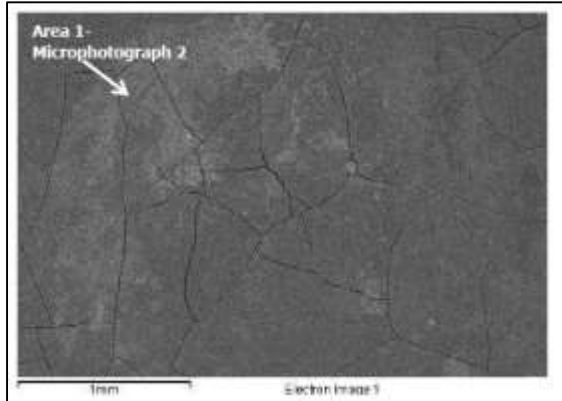
(a)

As the images shown, membrane surface is covered by thin organic fouling that didn't allow distinguishing membrane structure. On this thin organic covering, there is presence of sodium chloride dendritic growing characteristic of seawater membranes surface and some particles of different composition were detected also.

General analysis of this membrane surface sample indicates that there is a main presence of sodium chloride, aluminosilicates and small percentages of elements that are common also on sea water fouled membranes: magnesium, calcium, etc.

The general view of GA160355 membrane surface showed that there is a significant covering of membrane surface which shows inorganic component more concentrated on spacer support area (Figure 5 a).

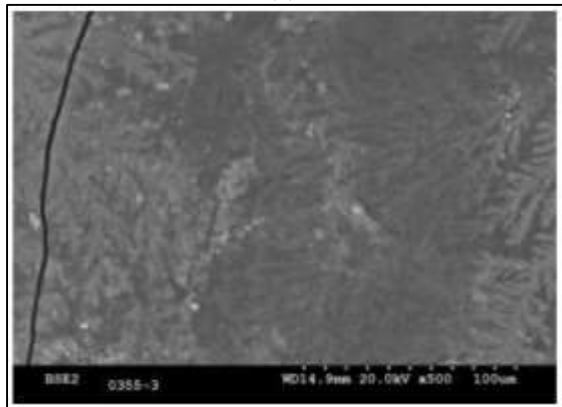
(b)

The second SEM micrograph of the surface of the fouled membrane (Figure 5 b) showed the detail of fouling on area 1 – spacer support area Inorganic component of fouling is concentrated on spacer support area.

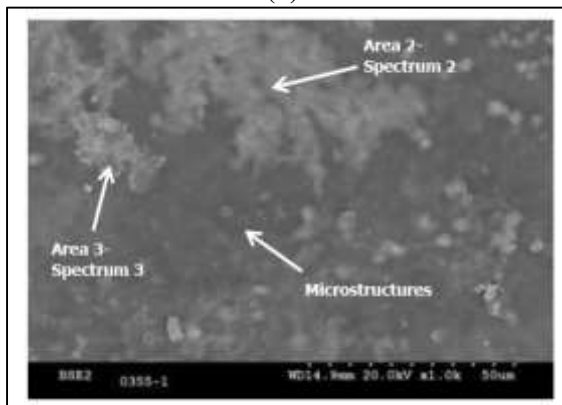
(c)

The third SEM microphotograph of the surface of the fouled membrane (Figure 5 c) showed the detail of fouling on spacer support area. The figure 5c shows that fouling is composed by a mixture of an organic component with very small particles and presence of microstructures.

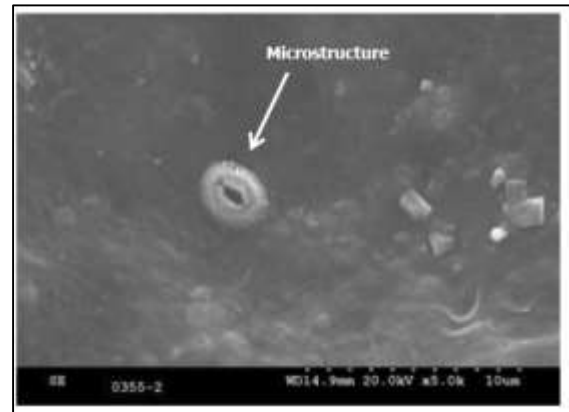
(d)

The last SEM microphotograph of the surface of the fouled membrane (Figure 5 d) showed the detail of membrane surface at high magnifications on area with thin organic covering. It's revealed that on none of the areas, membrane structure couldn't be distinguished. There is also presence of microstructures.

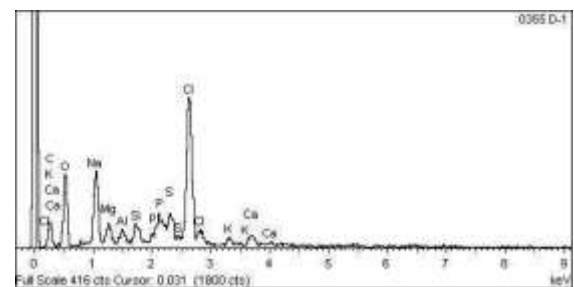
**Figure 6-**General analysis of GA160355 membrane fouling (Spectrum 1F)

The general analysis of GA160355 membrane fouling indicates that fouling is composed by an organic component, sodium chloride, aluminosilicates, calcium, and common elements on sea water membranes fouling as sulphur, magnesium, phosphorous and potassium (Figure 6). While the analysis of area 1 on GA160355 membrane fouling indicates that fouling is composed by an organic component with chlorine, sodium chloride small percentages of the rest of elements detected on the general analysis carried out on membrane surface sample (Figure 7).

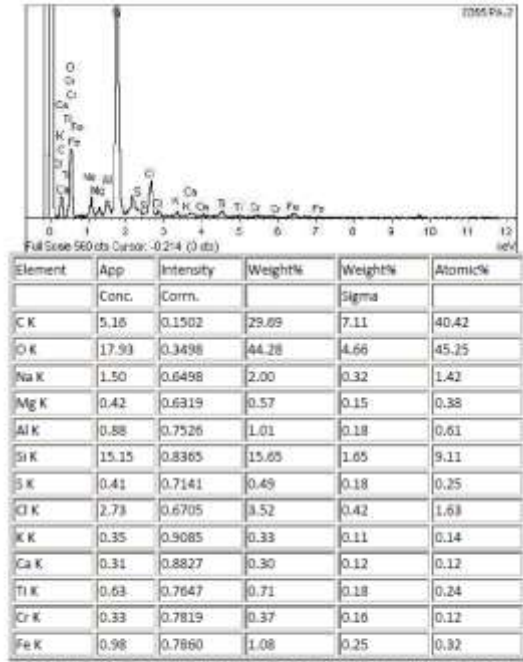
Figure 9. Analysis of particle 2 from GA160355 membrane feed end

The analysis of particle 2 from GA 160355 is mainly composed of silica, with small percentages of sodium chloride and iron and aluminosilicates (Figure 9).

Spectrum 2P.- Analysis of particle 2 on GA 160355 membrane feed end. Mainly composed of silica, with small percentages of sodium chloride and iron and aluminosilicates

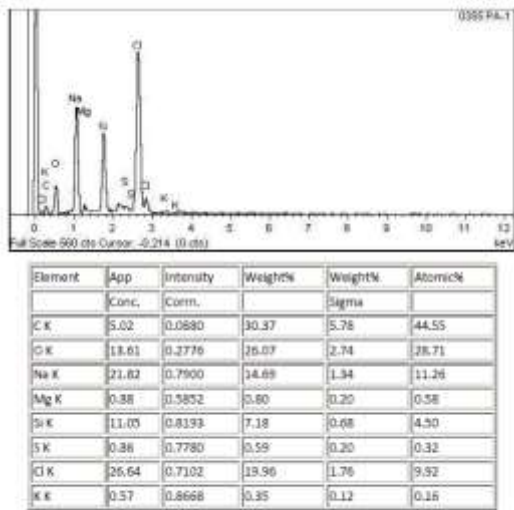
Figure 8. Analysis of particle 1 from GA160355 membrane feed end

The analysis of particle 1 from GA 160355 showed the major constituents to be sodium chloride and silica (Figure 8).

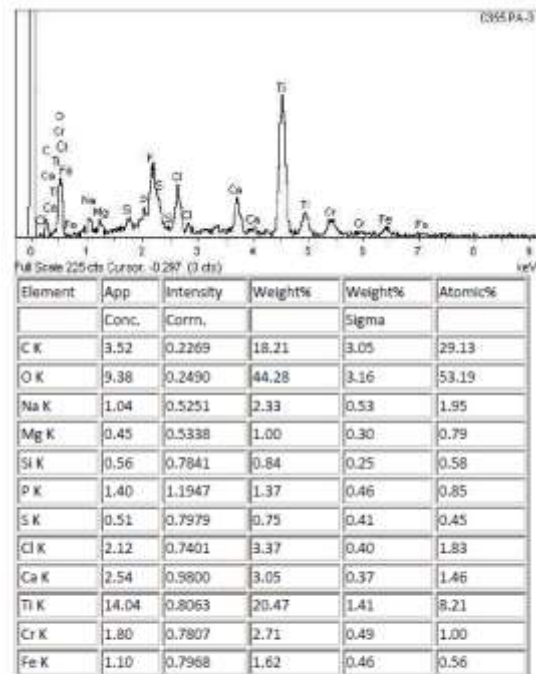
Figure 10. Analysis of particle 3 from GA160355 membrane feed end

While the last particle 3, metallic particle was composed of titanium with small percentages of chromium and iron. We found also presence of sodium chloride, calcium phosphorous, magnesium (Figure 10).

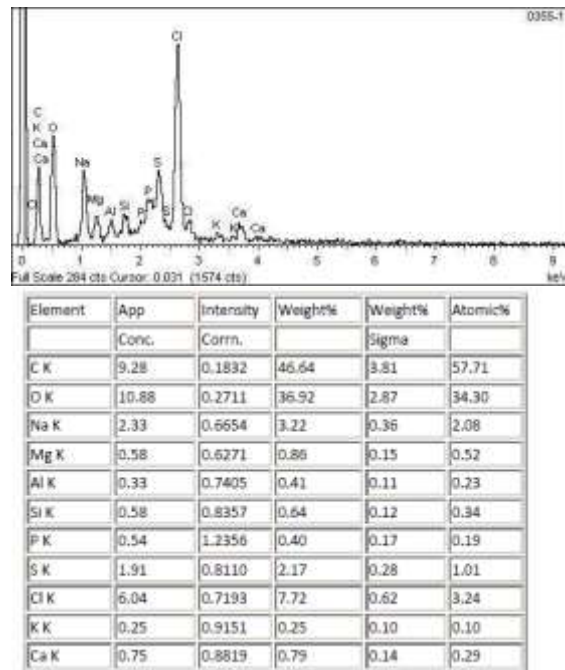
Figure 11. EDS General analysis of GA 160355 membrane surface.

The EDS analysis of membrane surface shows that the fouled membrane surface consisted of

membrane components (carbon, oxygen and sulphur), sodium chloride, chlorine, aluminosilicates and common elements on sea water membranes fouling (magnesium, calcium and potassium)(Figure 11).

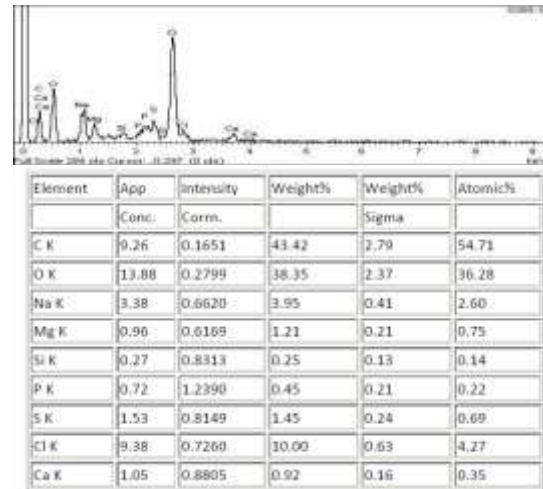
Figure 13. EDS Analysis of area 2 on GA 160355 membrane surface.

Whereas, the EDS analysis of area 1 indicates that fouled membrane surface consisted of membrane components (carbon, oxygen and sulphur) and presence of sodium chloride and chlorine (Figure 12). The EDS Analysis of area 2 shows that fouled membrane surface consisted of Membrane components (carbon, oxygen and sulphur), sodium chloride and chlorine and common elements on sea water membranes fouling (Figure 13).

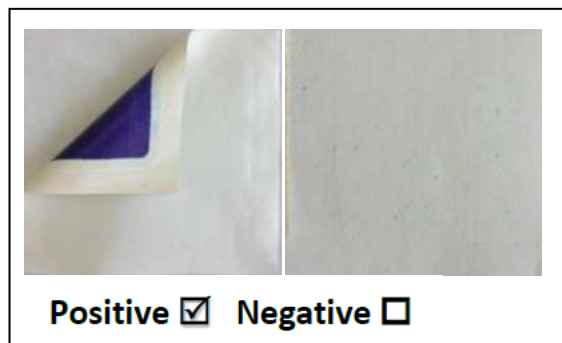
Figure 14. Methylene Blue Test of used fouled membrane

As shown in figure 14, the passage of dye was detected on GA160355 permeate side, which verifies that membrane has suffered some damage.

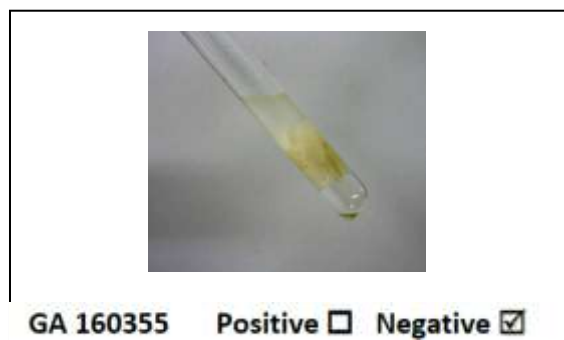
Figure 15. Fujiwara Test of used fouled membrane

The result showed no pink color was observed on the analytical solution, so contact of fouled membrane GA160355 with halogens was not detected.

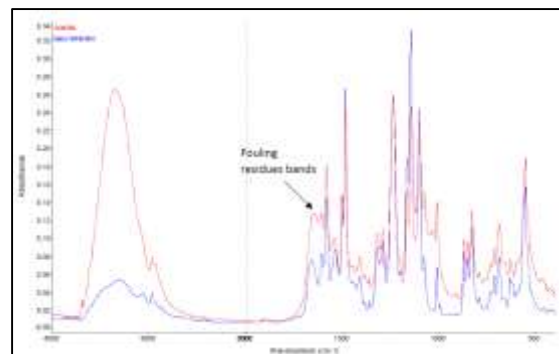
Figure 16. Comparison of ga 160355 membrane IR spectrum after a mechanical cleaning (red line) compared to membrane blank (blue line).

As shown in Figure 16, surface spectrum still shows some fouling residues, which don't allow checking polyamide bands conditions.
